MINISTRY FOR CLIMATE CRISIS AND CIVIL PROTECTION
EARTHQUAKE PLANNING & PROTECTION ORGANIZATION (E.P.P.O.)

THE FLORINA M5.5 EARTHQUAKE OF JANUARY 9, 2022

BRIEF REPORT ON ACCELERATION TIME HISTORIES ANALYSIS AND DAMAGE EVALUATION IN THE BUILDING STOCK

THESSALONIKI
JANUARY 2022

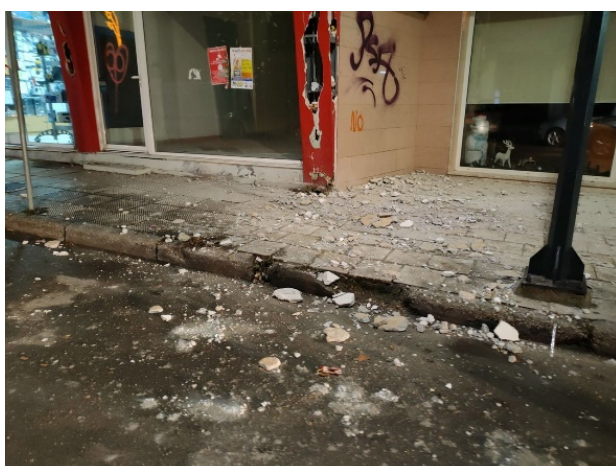
Based on the reports to date, damage to structures was rather limited in the city of Florina, given the magnitude and the proximity to the epicenter of the main earthquake. There were mainly falls of external plasters and marble claddings in old buildings and in multistorey apartment buildings as well (**Figure 4.1a**), local failure of stone walls (**Figure 4.1b**), damage to balconies, as well as crackings at interior walls of houses (**Figure 4.1c,d**). A collapse of an uninhabited old house in the village of Agia Paraskevi, north of Florina was also reported. In the city of Florina, the neoclassical building of the Folklore Museum of the Florina Cultural Club, of cultural heritage importance, presented limited damage, namely falls of external plasters and a failure of a decorative element on the roof of the building (**Figure 4.2**). After the completion of autopsies by the authorities in the wider earthquake-stricken area, damage to various categories of structures will be recorded in more detail, in order to draw more conclusions about the vulnerability of the structures in the Greece.

Fall of plasters from masonry buildings in case of an earthquake is rather common and is one of the first forms of "failure" that occurs. This is justified in two ways: (i) Plasters are made of low-strength materials which are particularly brittle. In many cases, they are already worn and weakened due to environmental factors, and due to the seismic excitation, they detach and fall. ii) Detachment and fall of plasters are also due to in- and out- of plane deformation of the masonry walls. The strength of masonry (of stones or bricks and building mortar) as proposed by the Code for Assessment and Structural Interventions in Masonry Buildings (KADET 2021 - draft) is at least three times the plaster strength. Masonry walls deform and develop cracks during the seismic excitation, resulting in the cracking and detachment of plaster, with a possible simultaneous fall of smaller infill stones (**Figure 4.1a,b, 4.2b,c**).

Figure 4.1. Observed failures from the earthquake of 09/01/2022 Photo sources: (a) Twitter (b) www.skai.gr

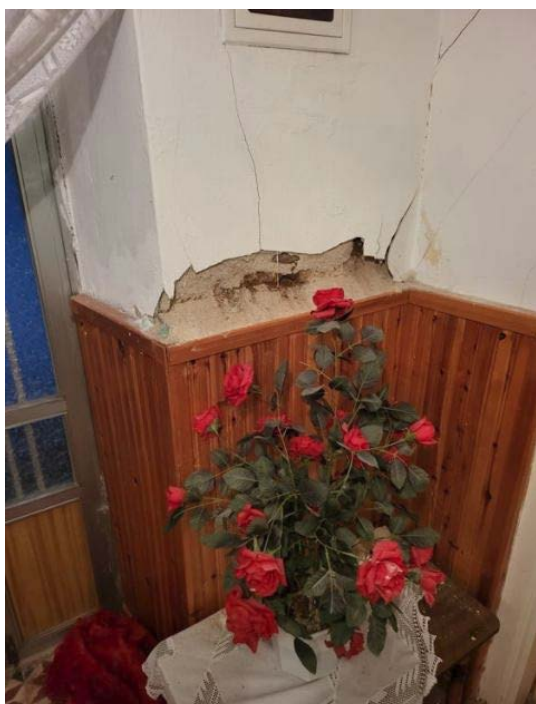
(c) (d)
Figure 4.1. (continued) Observed failures from the earthquake of 09/01/2022. Photo sources:
<https://neaflorina.gr>

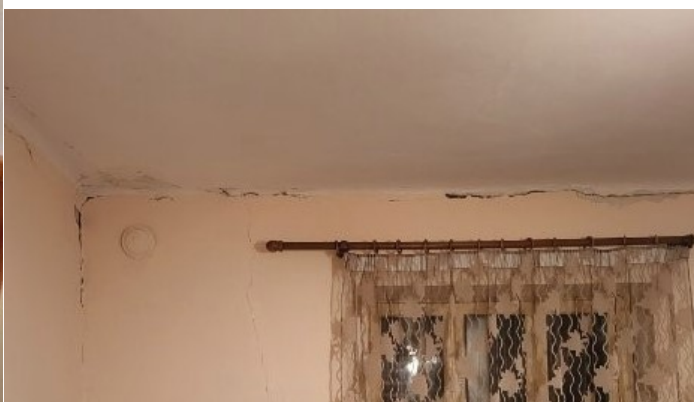
Another form of cracking which is also first to appear in R/C buildings is the detachment of infill walls from the surrounding RC frames. It is a common form of failure which is among the first to appear in R/C buildings (and sometimes the only observed). This is due to the different response of masonry and reinforced concrete elements for two reasons: i) The drift ratio for which cracks develop in the two materials is very different, with that for reinforced concrete elements being about three times the respective one for infill walls. Thus, in several cases cracks appear in infill walls, while the surrounding reinforced concrete frames experience no damage. Typically, these cracks initially appear at the interface between the infill walls and the surrounding R/C frames. ii) Cracks in reinforced concrete elements with no significant yield of the longitudinal reinforcement (reinforcement elongation in the order of 2-4‰) close after the seismic event and are not perceived during the on-site macroscopic autopsies. On the contrary, cracks in infill walls leave a trace on the plaster, and are easily observed (**Figure 4.1.d**).

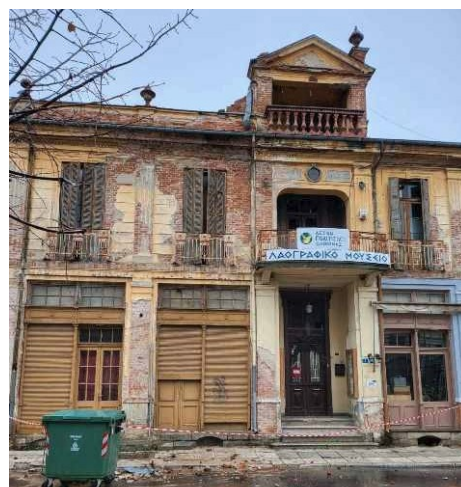
Figure 4.2. Folklore Museum of Florina (a) before and (b), (c) after the earthquake of 09/01/2022. Photo sources: (a) Google Earth (b) <https://neafiorina.gr> (c) www.skai.gr
