# **S. IONIAN SEA EARTHQUAKE M 6.8 ON 25/10/2018**

## **STRONG GROUND MOTION AND EFFECTS ON SOIL AND BUILT ENVIRONMENT**

THESSALONIKI  
NOVEMBER 2018

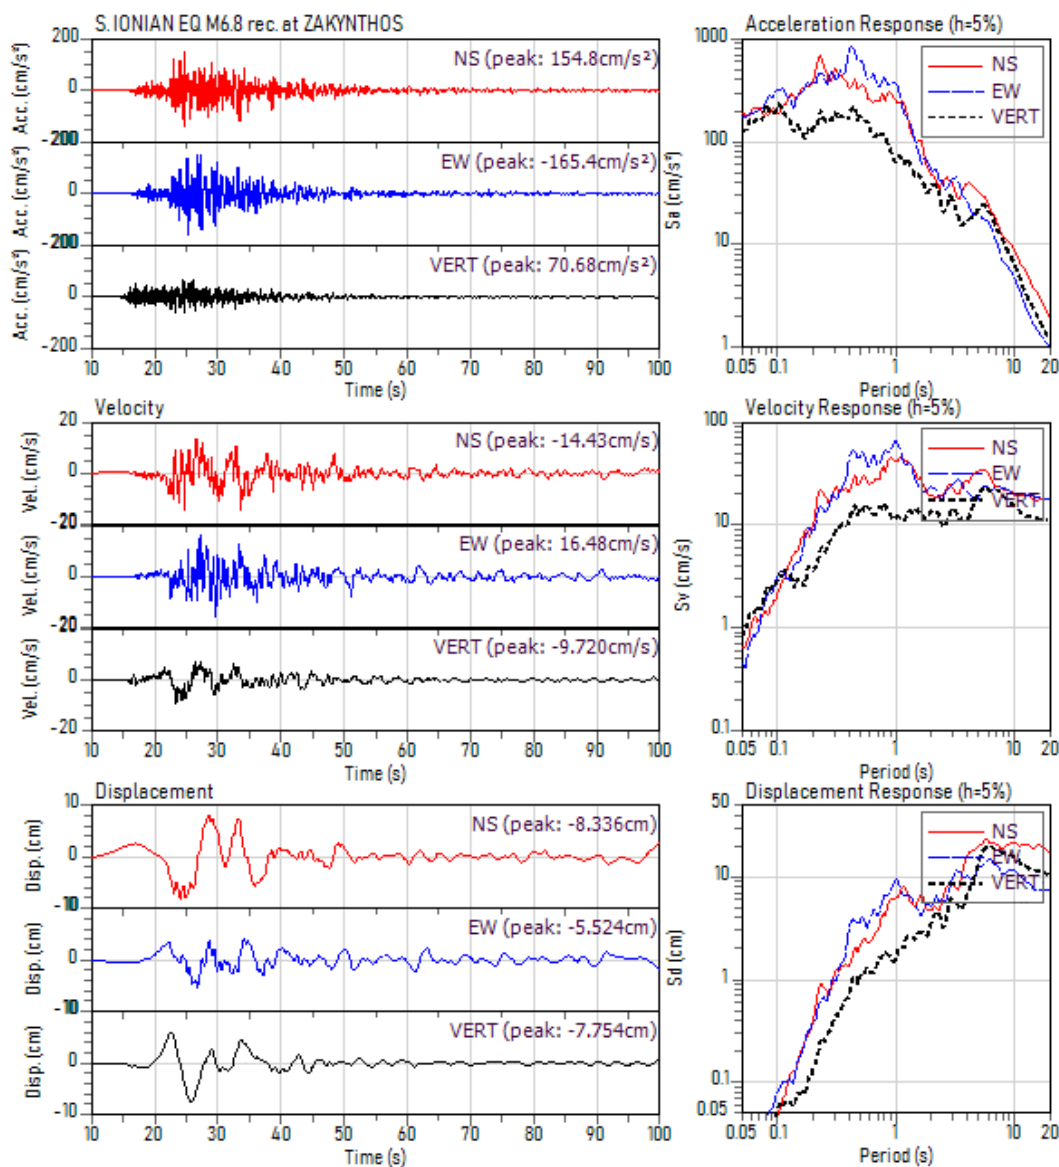
Figure 8. Time histories of acceleration, velocity and displacement for the 3-component recordings in the Zakynthos town station (ZAK2), and their corresponding acceleration, velocity, displacement response spectra.

Processing of the ZAK2 and KRI1 accelerograms was made using the software SCREAM&ART3 Guralp Systems Ltd. As well as the VIEWwave (Kashima, 2016). The results in term of peak ground acceleration, velocity and displacement values are given in Table III. In Figs. 8 and 8, acceleration, velocity and displacement time histories are shown, together with their corresponding acceleration, velocity and displacement response spectra (damping  $h=5\%$ ). The Arias intensity and an estimated significant duration of ground motion is provided in Figure 10. Fourier spectra of the ZAK2 and KRI1 recordings shown in Figure 11, exhibit a corner frequency,  $f_c \sim 0.1$ sec, close to the one expected for such a magnitude event. The estimated displacement particle motion presented in Figure 12 shows an almost north-south motion of about 15cm in ZAK2 and 17cm in KRI1 station.

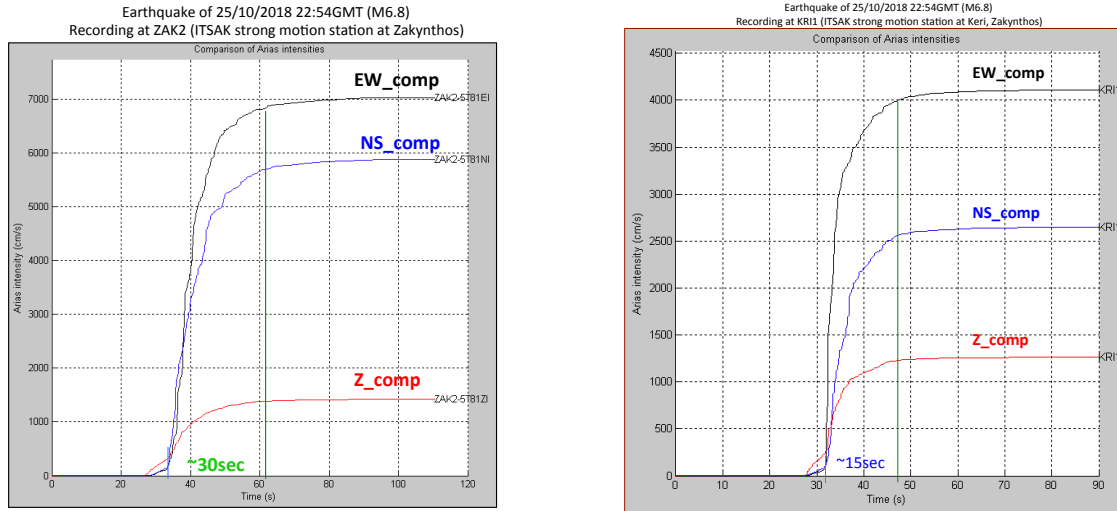
Figure 10. Arias Intensity and estimated significant duration of strong ground motion for the 3 components of the acceleration time history in Zakynthos town (ZAK2, left) and Keri (KRI1, right).

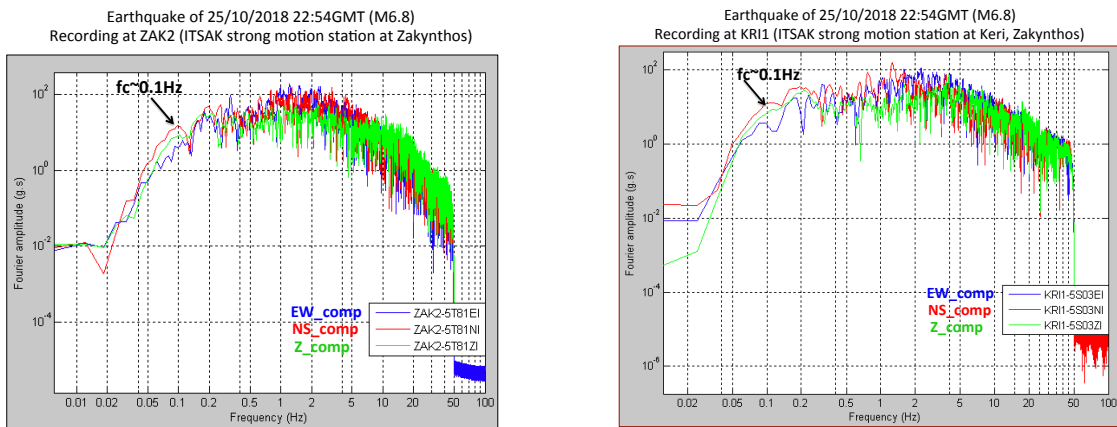
Figure 11. Fourier spectra and corresponding corner frequency ( $f_c$ ), for the 3 components of the acceleration time history in Zakynthos town (ZAK2, left) and Keri (KRI1, right).

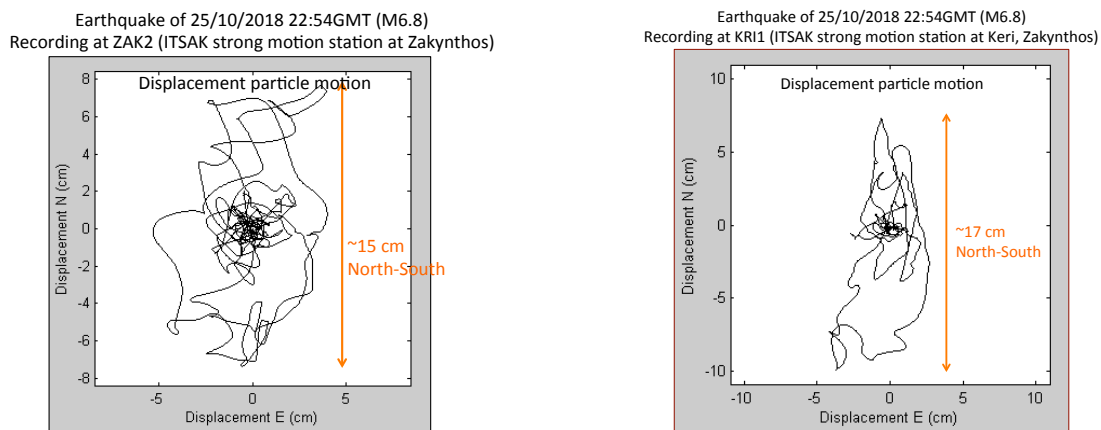
Figure 12. Displacement particle motion observed at Zakynthos town (ZAK2, left) and Keri (KRI1, right).

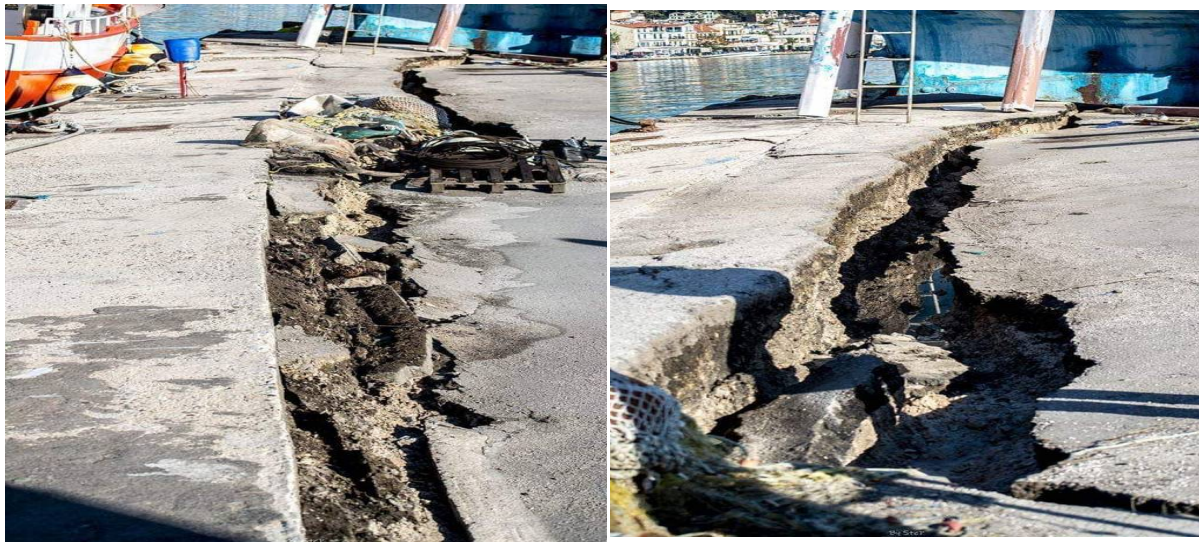
Extensive cracks parallel to the shoreline and failures of the quay walls in the form of permanent lateral displacement and tilting as well as settlement of the backfill were observed at the ports of Zakynthos (Pictures 1 and 2) and Ag. Sostis, following the **M** 6.8 earthquake of 26/10/2018. However, both ports remained functional after the earthquake.

Picture 2. Lateral displacement and tilting of the quay walls at the port of Zakynthos

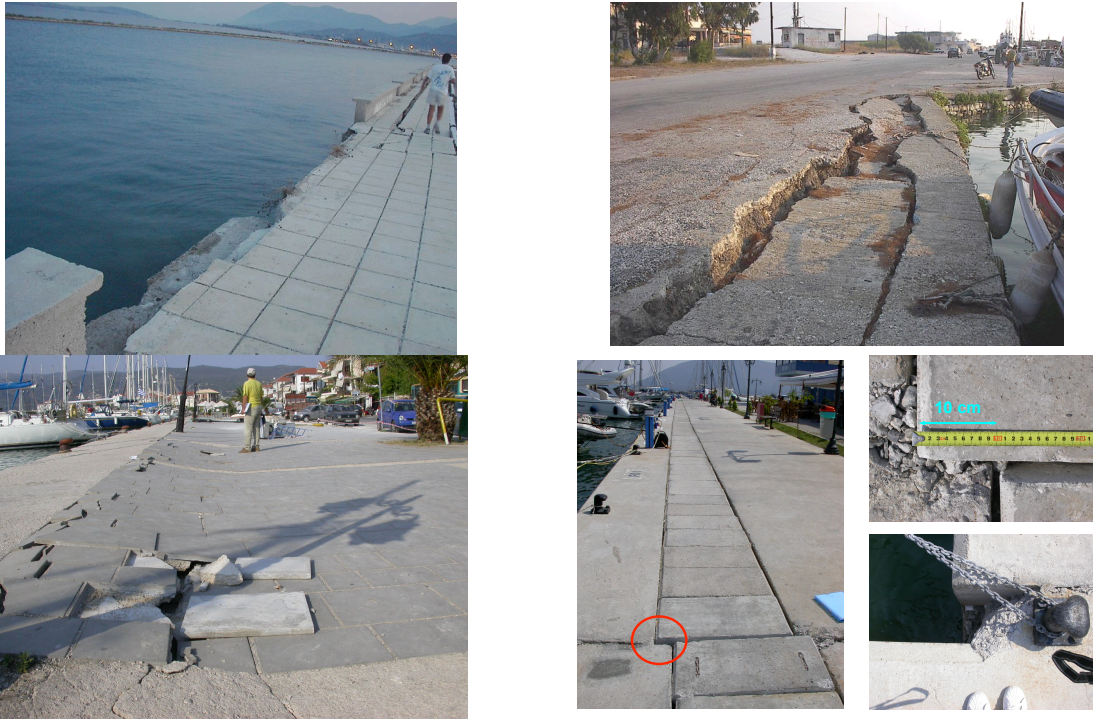
Picture 4. Earthquake-induced failures at the port of Lefkas, following the M6.3 earthquake of August 14, 2003.

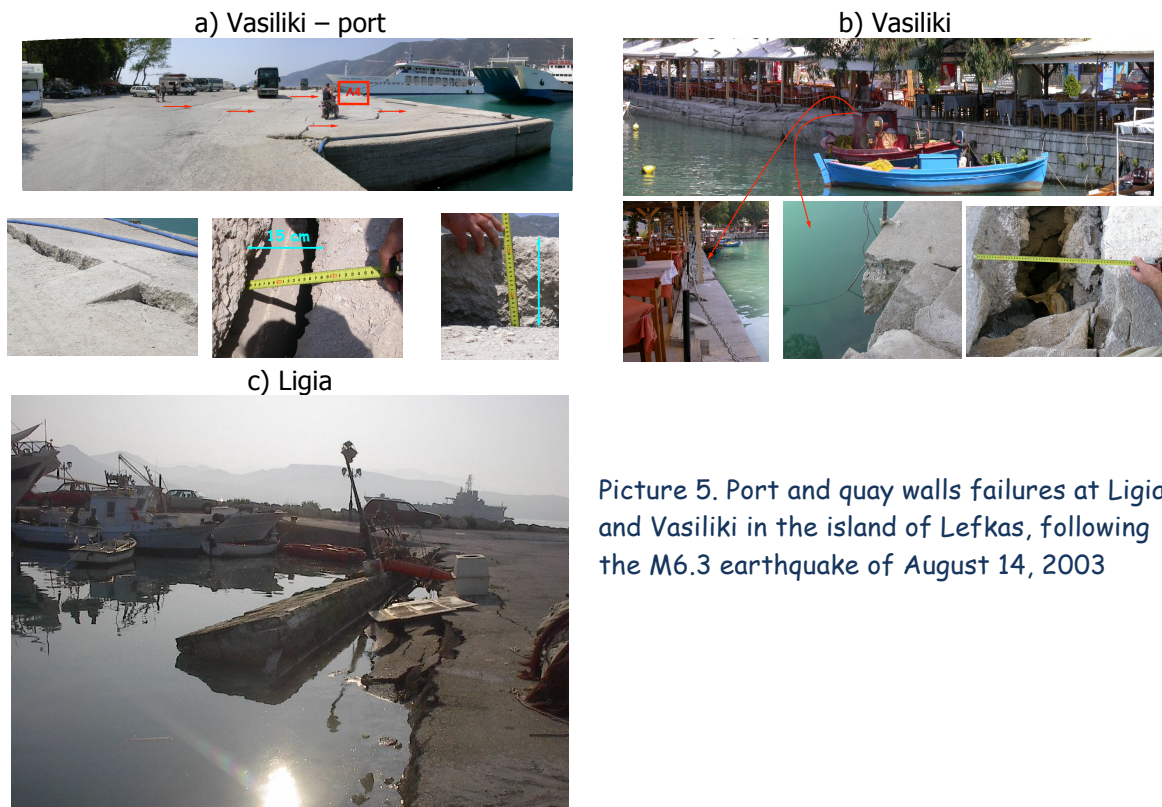
Picture 5. Port and quay walls failures at Ligia and Vasiliki in the island of Lefkas, following the M6.3 earthquake of August 14, 2003

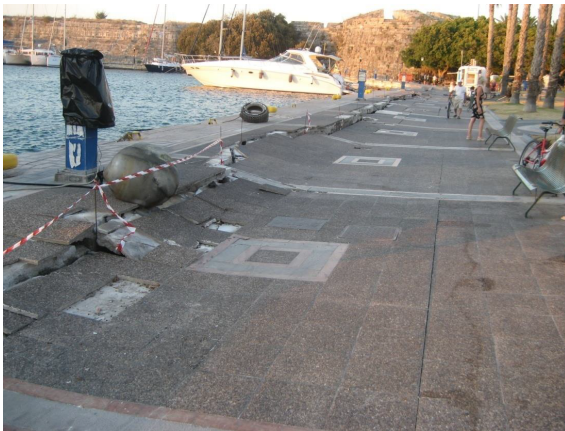
a) Kos – Port jetty

b) Kos – Port wharf

Picture 6. Earthquake-induced failures at the port of Kos, after the strong M6.7 earthquake.

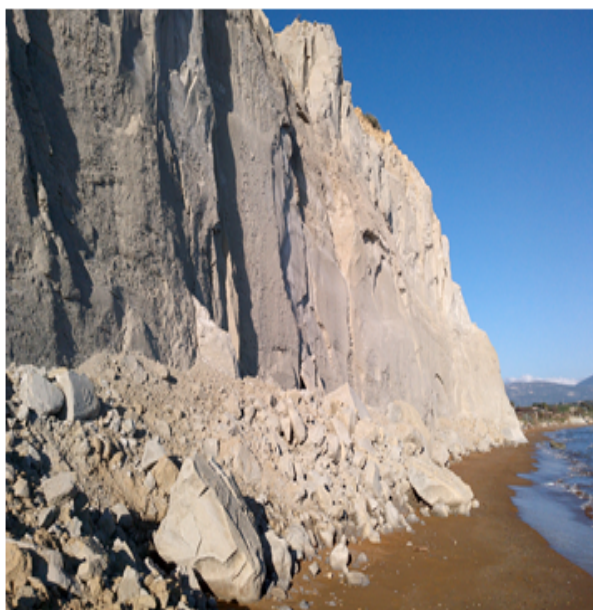
Picture 9.(a) Landslides of sandy marls in the shoreline of Xi and (b) Detachment of limestone rocks along Mirtos bay after the Cephalonia earthquakes (26/01/2104 και 03/02/2014).

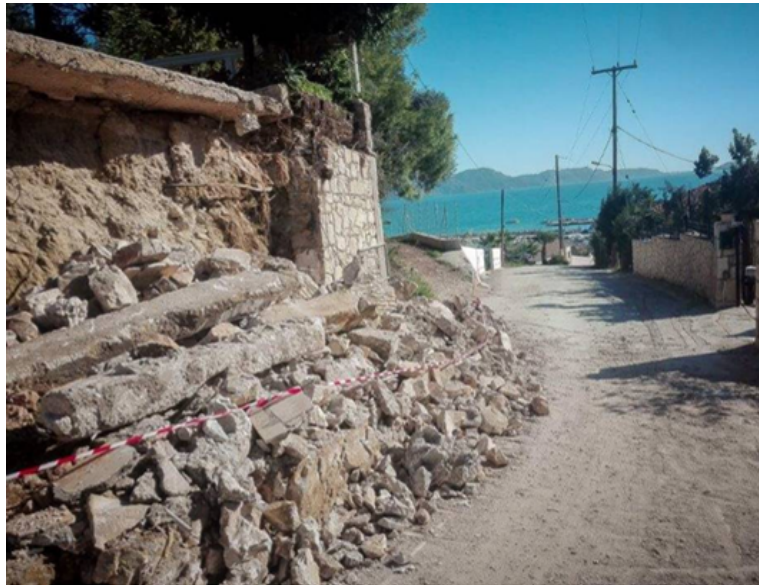
Failures of stone masonry retaining walls were also reported (Picture 10). Such out-of-plane failures or even total collapses was also typically recorded for the above type of retaining walls following previous strong earthquakes (Cephalonia 2014, Lefkas 2015) at the Ionian Islands (Picture 11).

Picture 10. Collapse of a stone retaining wall following Zakynthos earthquake (Source: <https://www.cnn.gr>)

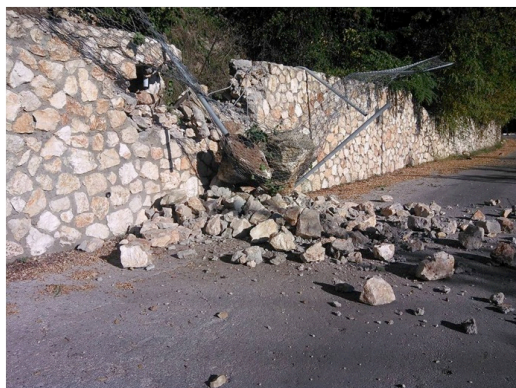
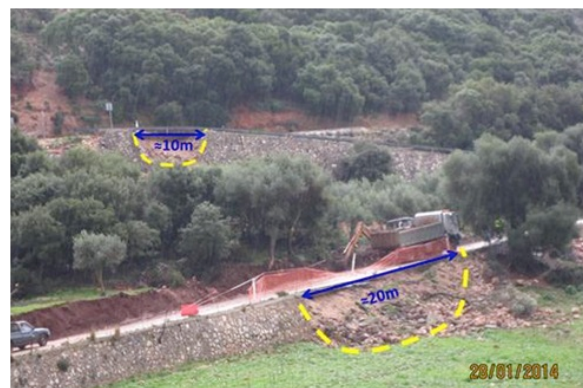
Picture 11. Typical failure types of stone retaining walls recorded after the Lefkas, 2015 (left) and Cephalonia, 2014 (right) earthquakes

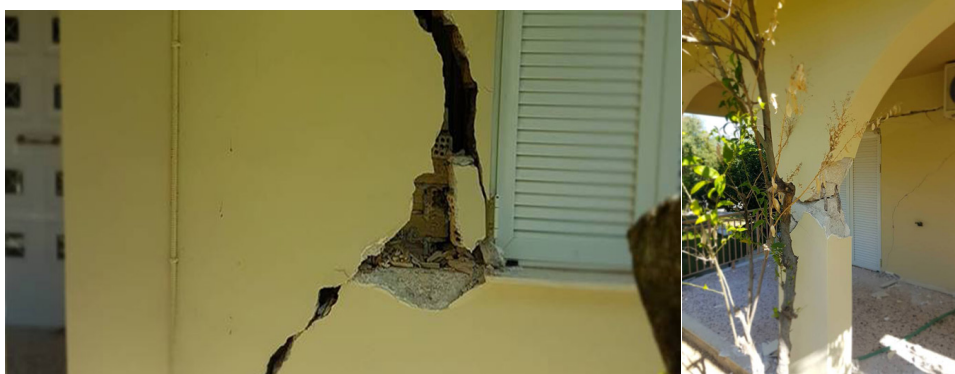
Traditional buildings built according to the local seismic provisions of 1953 presented some serious damage mainly to secondary structural elements (Pictures 12, 13). Among these, worth mentioning is the Castle-Monastery at the Strofathes island, due to its cultural importance (Picture 14).

Picture 12. Traditional building at Zakynthos town

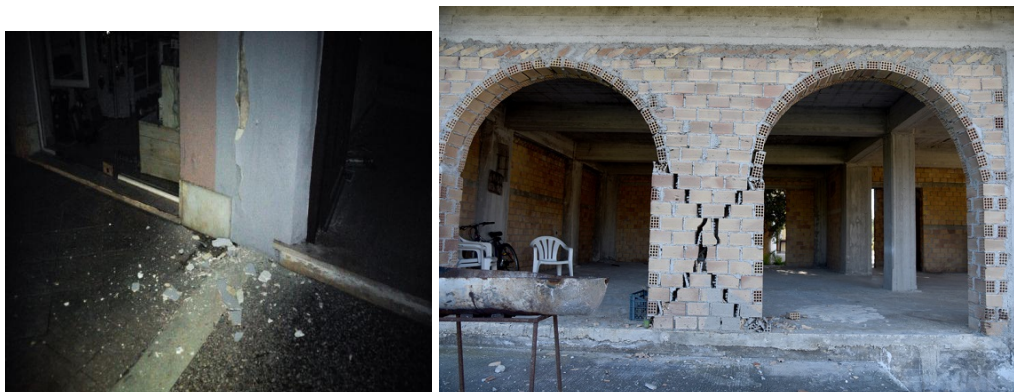
Picture 13. Observed damage at Zakynthos town

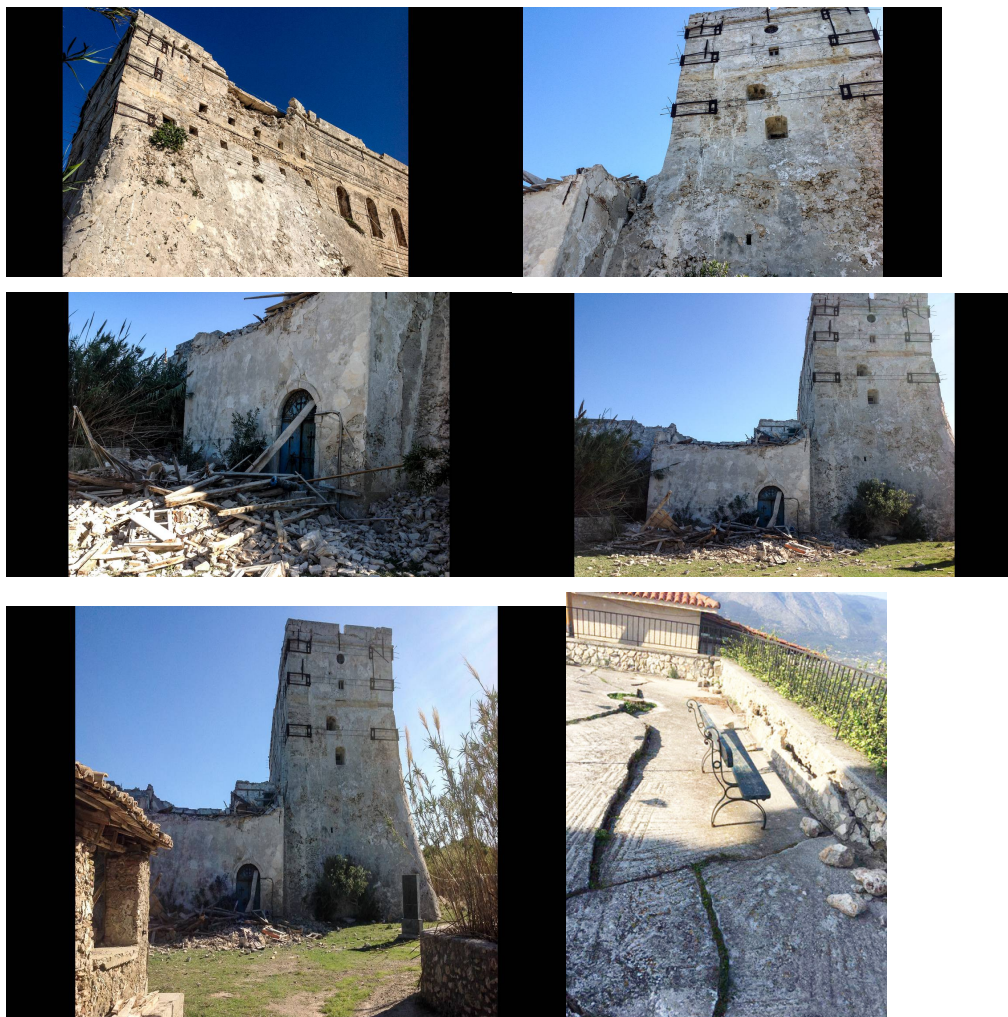
Picture 14. Observed damage at the Castle-Monastery at Strofathes island
